### **GATKE DUMP**

How Institutional and Engineering Controls
Transformed an Industrial Waste Site into the
Orthopaedic Capital Center

Presented by: Brian Horvath

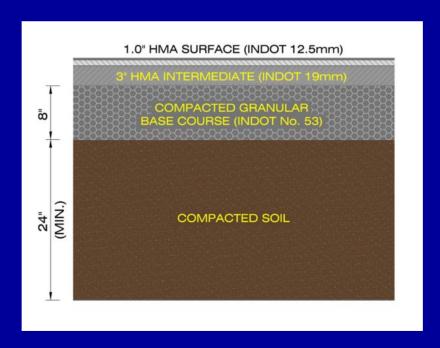
## **Engineered Barrier- Asphalt Cap**

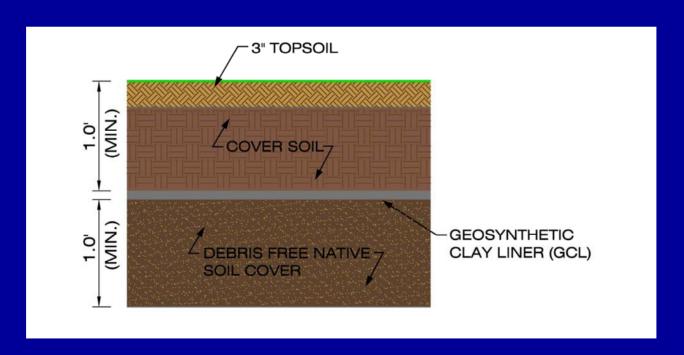
# **Engineered Barrier-Soil/GCL Cap**

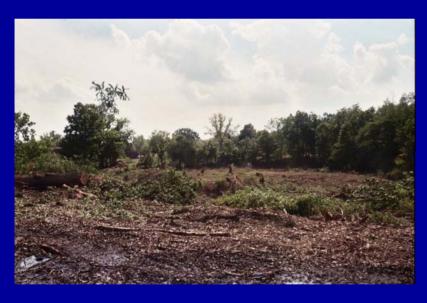
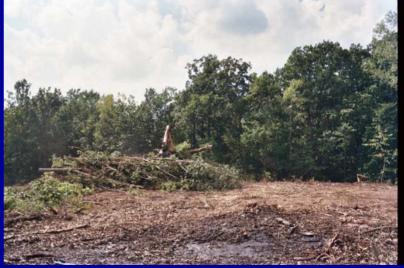
# **Clearing and Grubbing**

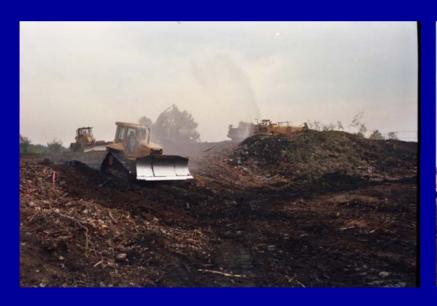
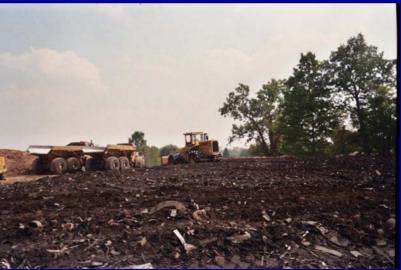
## **Waste Grading**

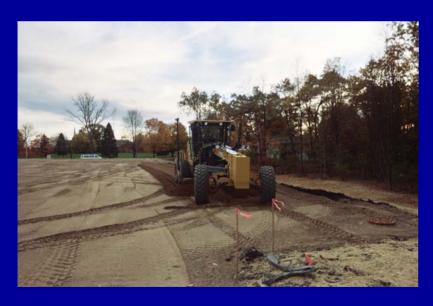
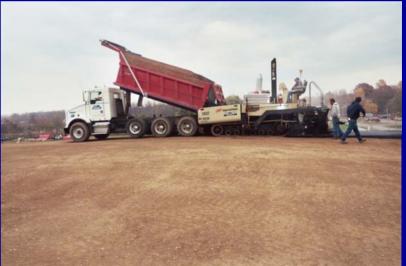
### **Pavement**

- Quarterly inspections for cracks wider than 1/8", excessive surface cracking, and differential settlement
- Note locations of any longitudinal cracks, alligator cracking, rutting, detaching asphalt, etc.
- Clean areas of excessive oil from parked cars

- Routine crack sealing
- ⇒ Seal coat
- Chip and seal
- Patching
- Resurfacing
- Removal and replacement

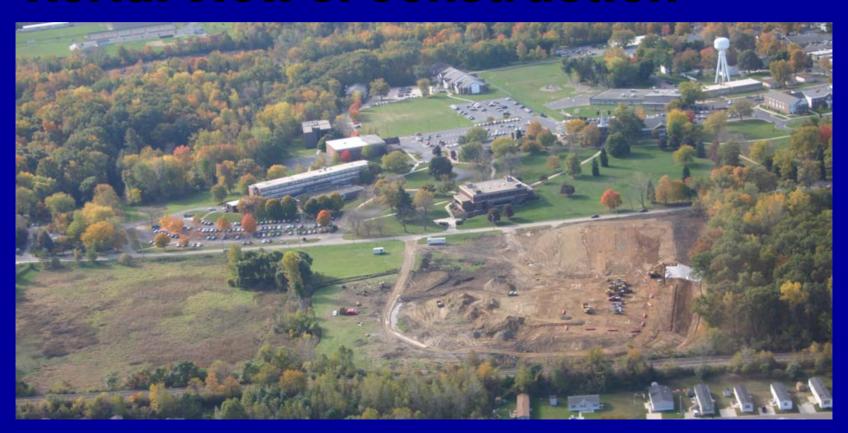
### **Aerial View of Construction**

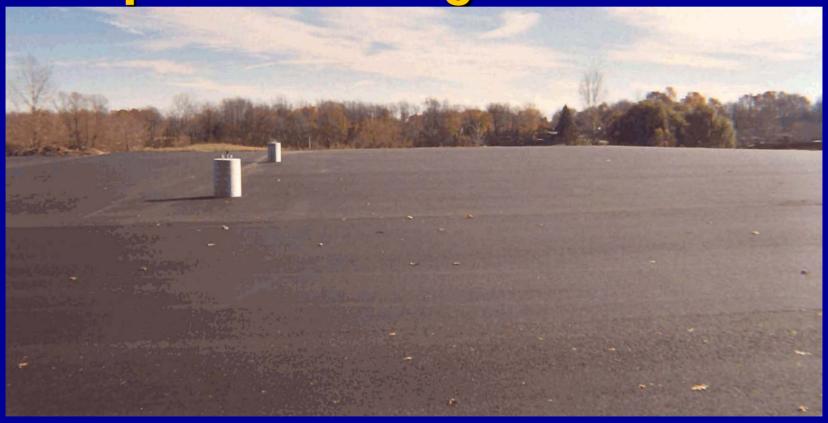
# **Completed Parking Lot**
